220712 AND 220712A STARTER REPLACEMENT PROCEDURE

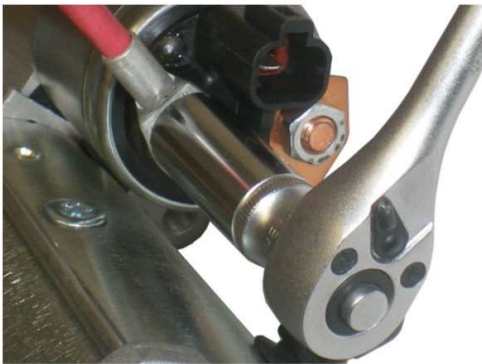
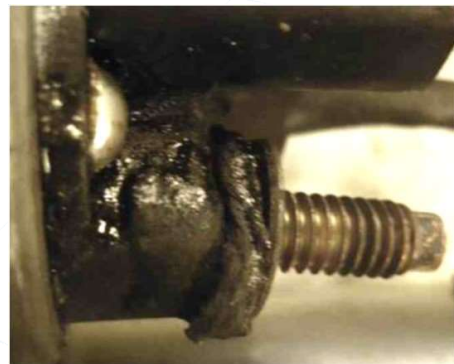
The vehicle CHEVROLET Captiva (Diesel engine 2,2L Z22D1 4 cylinders 16v) is sold with an inadequate size of the battery cable. In normal operation, engines' vibrations can cause tensions along the cable and you may lose the nut. Consequently, abnormal current flow and temperature increase in the connection area can damage battery cable and starter.

1. Fix the nut adequately
2. If it is necessary, replace the cable with longer one earth contact.
