209270 ALTERNATOR CLUTCH PULLEY AND/OR BEARINGS FAILURE TECHNICAL BULLETIN

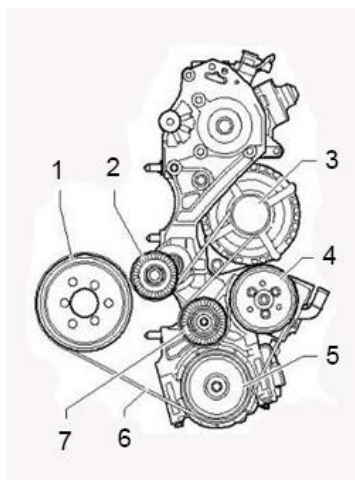
The problem may be caused due to different factors which included the drive belt, the tensioner, A/C compressor, water pump, power steering pump and their components, the crankshaft pulley.

- 1 – A/C Compressor pulley
- 2 – Tensioning roller
- 3 – Alternator pulley
- 4 – Water pump
- 5 – Crankshaft pulley
- 6 – Poly-V belt
- 7 – Idler roller

It is recommended that all parts within the drive belt system are carefully checked before fitting the new alternator.

Ensure the belt is not stretching mark or damaged.

Ensure the tensioner operates correctly.

Ensure all pulleys and idler roller are correctly moving.

Ensure the crankshaft pulley has the correct and restricted axial play and is in good condition.

In case of the above items have any faults or suspected marks, the component must be replaced, to prevent premature failure of the alternator and other parts which may invalidate the warranty.
