# 664089

## INTERIOR BLOWER

### REPLACEMENT PROCEDURE

Shown below, you can find the procedure that you must follow to replace interior blower cap about Denso code DEA09020  
This procedure is available for ERA code 664089.

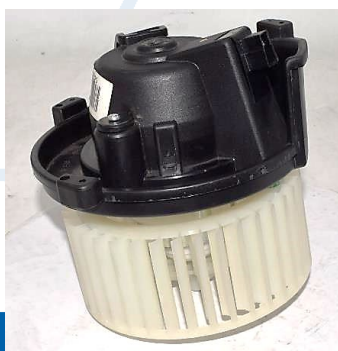
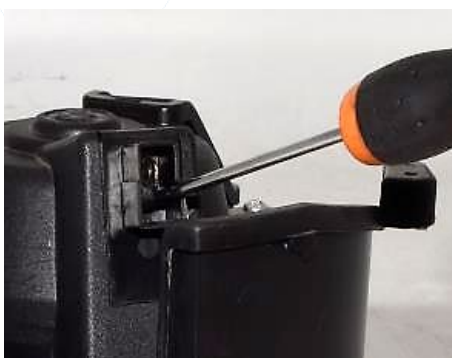
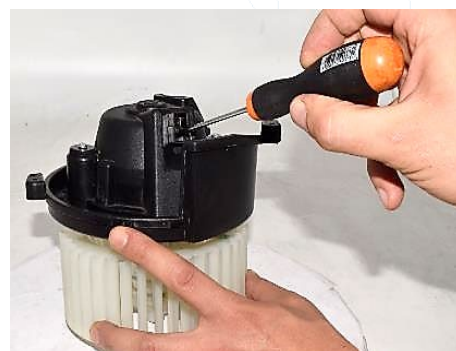
- 1) Dismantling connectors

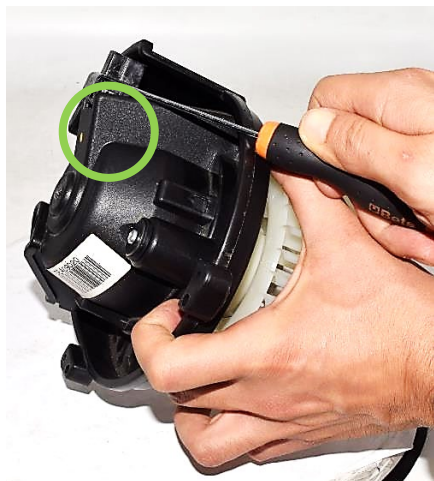
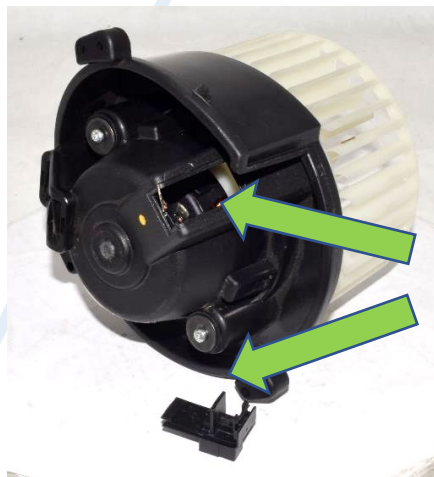
## 2) Dismantling of connectors compartment (highlighted in green)

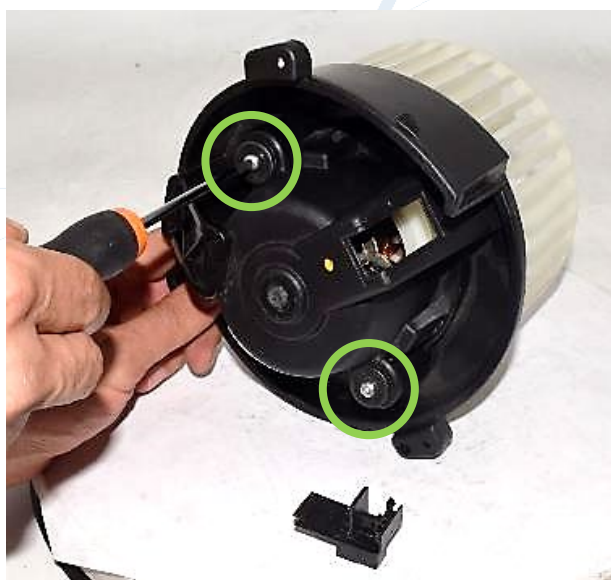
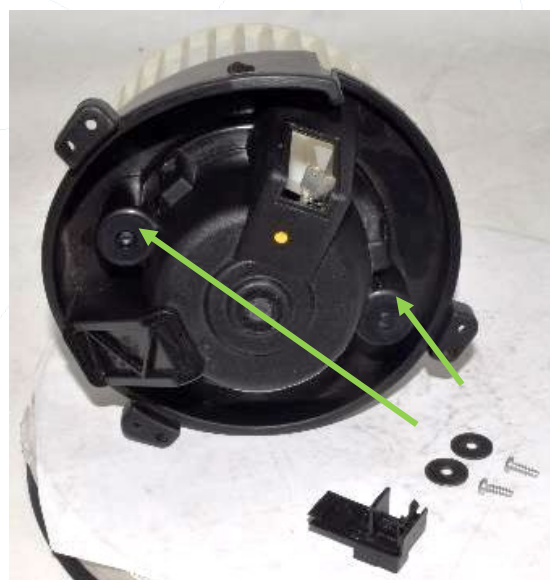
## 3) Dismantling of anchor points

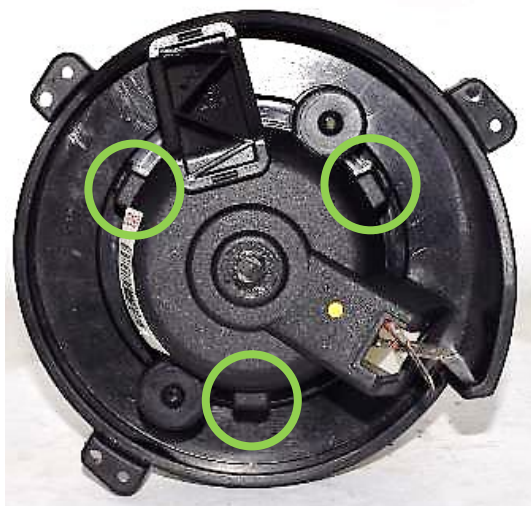
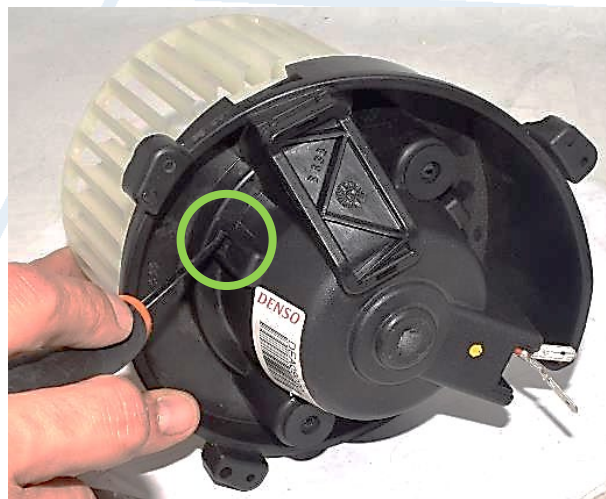
4) Unhooking of the rubber seals

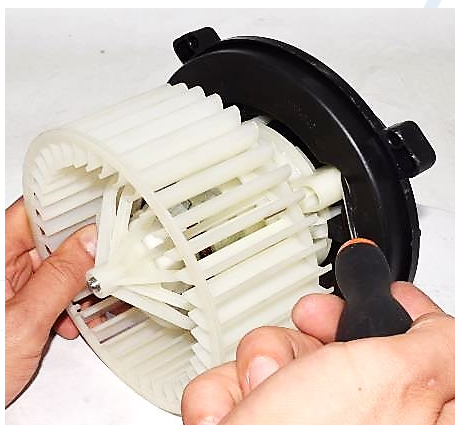
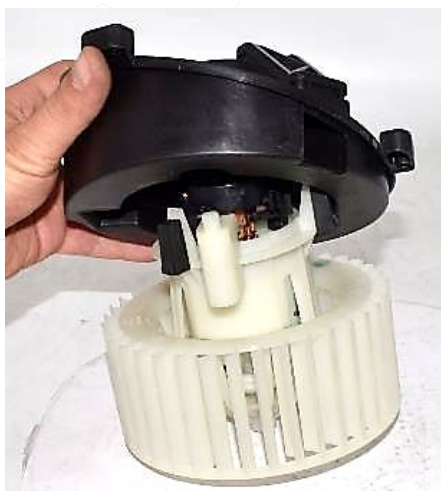
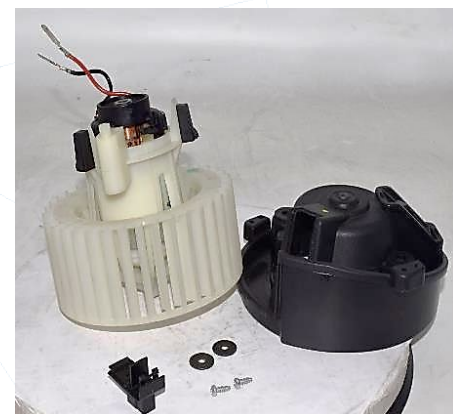
5) Extracting interior blower cap

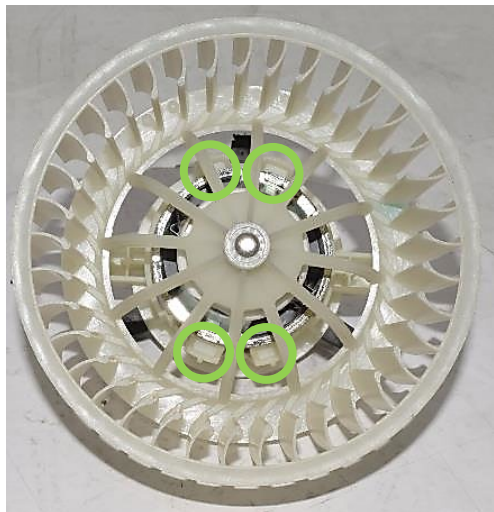
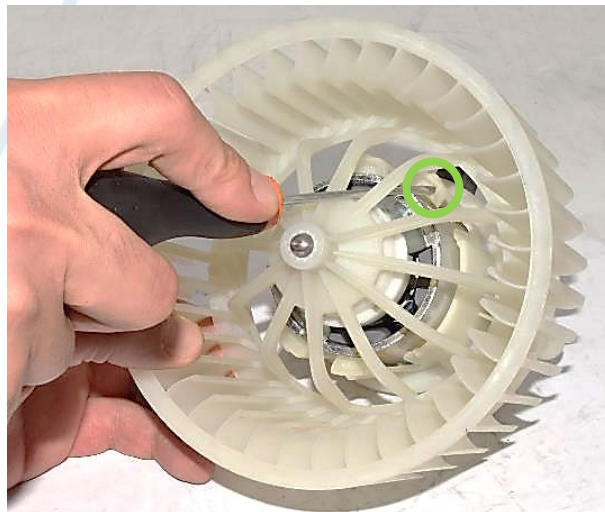
6) Unlocking of the 4 anchor points in interior blower

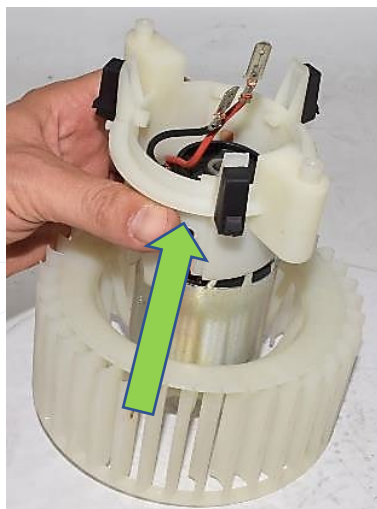
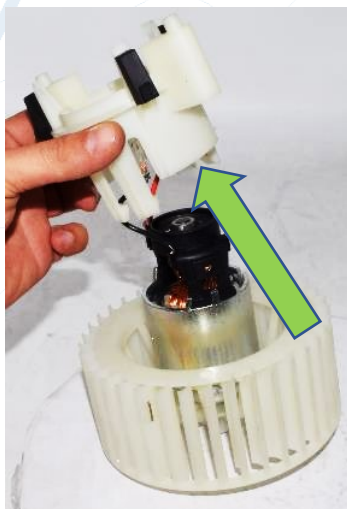
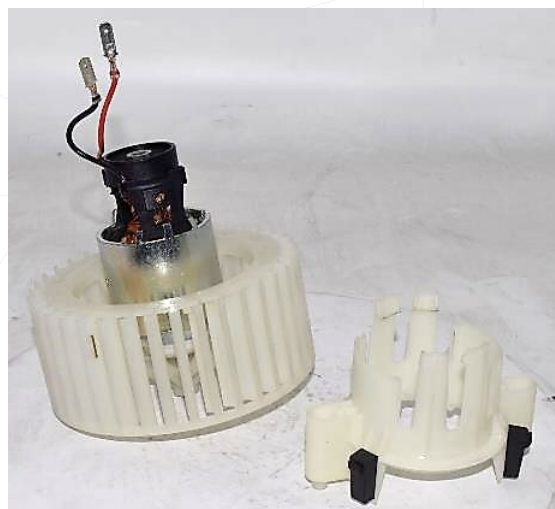
7) Remove the interior blower engine from its compartment

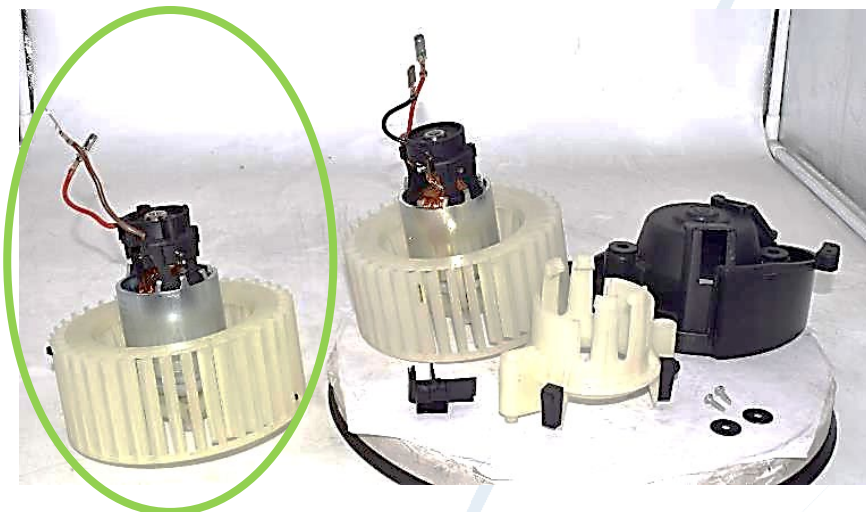
8) Use new interior blower (ERA 664089) and put together each parts, following the reverse process
